Evaluation of the Role of Green Infrastructure in Mitigating Stormwater Runoff: A Case Study of Kinamba Catchment, Kigali City

Ganza Musabyimana Aimee Dieze^{1*} & Martin Vincent Nsanzumukiza¹

Dieze, G. M. A. & Nsanzumukiza, M. V. (2025). Evaluation of the Role of Green Infrastructure in Mitigating Stormwater Runoff: A Case Study of Kinamba Catchment, Kigali City. *African Journal of Climate Change and Resource Sustainability*, 4(1), 372-391. <https://doi.org/10.37284/ajccrs.4.1.3126>.

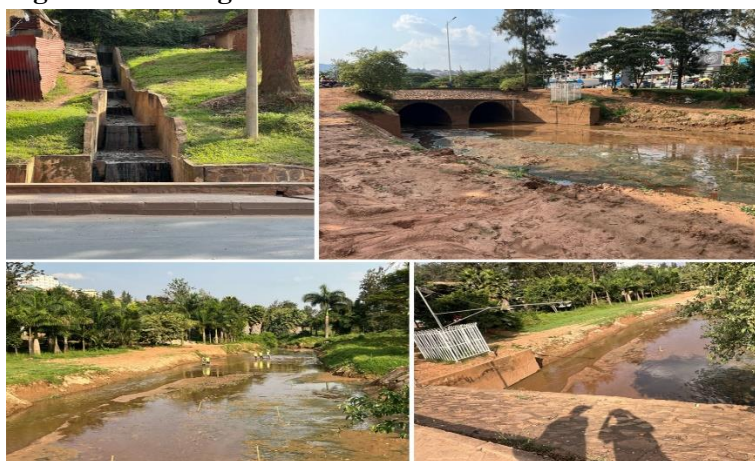
Figure 2: Existing Green Infrastructure in Kinamba Area

According to the field observations and **Figure 2** below (showing different existing green infrastructure present in the Kinamba area), there is clear evidence of insufficient and poorly functioning green infrastructure. This includes degraded drainage channels, a lack of adequate rain gardens, and widespread impermeable pavements. These conditions reduce the catchment's ability to absorb and slow stormwater runoff, intensifying flood risks and water quality challenges.

Figure 2. illustrates the current distribution of green infrastructure within the catchment. The dominant GI elements include grassland patches interspersed with tree-covered areas, concentrated primarily in less densely built-up regions. While these green spaces are present, their spatial coverage is limited and fragmented, suggesting potential challenges in providing continuous ecological services for effective stormwater management.
