East African Journal of Engineering

Evaluation of Performance of Pavement Founded on Reinforced Earth Sections along Outer Ring Road, Nairobi

Kirima Doreen Kiende^{1}, Dr. Simpson Nyambane Osano, PhD² & Prof. Sixtus Kinyua Mwea, PhD²*

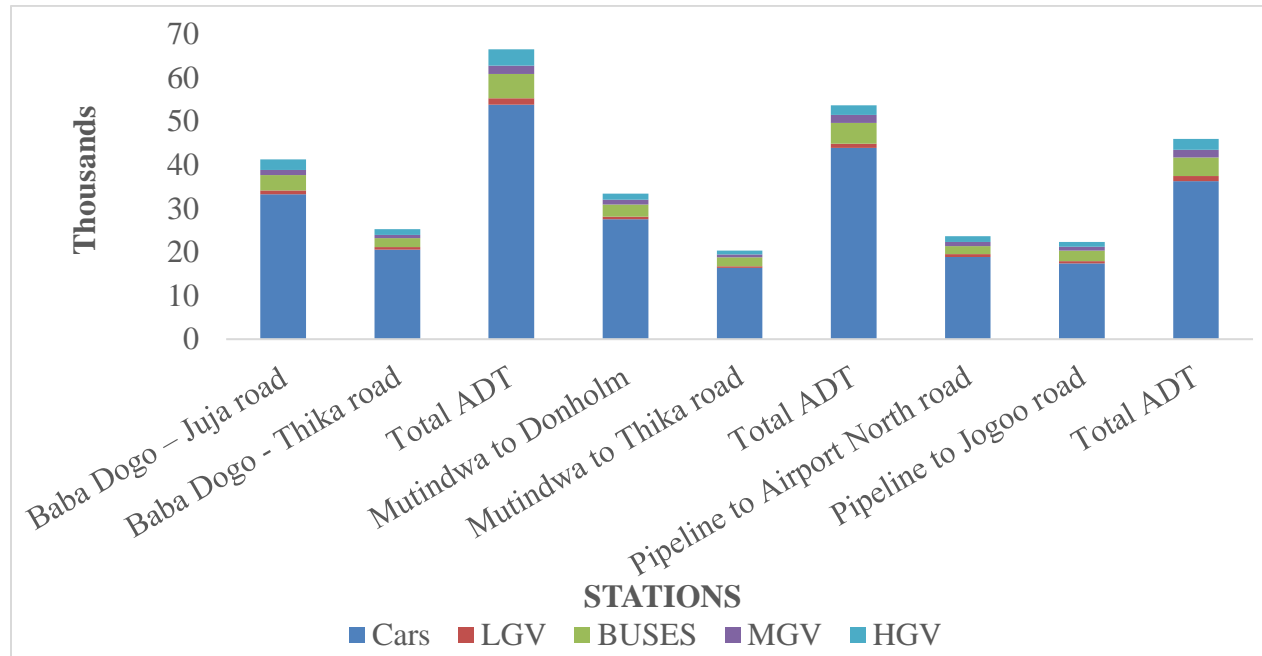
Figure 1: Traffic volume in ADT – 2021

Baba Dogo station recorded the highest Average Daily Traffic (ADT) for each direction and for the

two directions combined, while Pipeline station recorded the lowest. It was established that the traffic volume towards the Airport North Road (Eastern bypass) direction was higher than traffic towards Thika roadside for all stations. The traffic volume is displayed in *Figure 1*, below.

Cars recorded the highest volume in all stations followed by buses and the least was light goods vehicles. Heavy Goods Vehicles (HGV) had a significant contribution to commercial vehicles. The increase in heavy goods vehicles on the road after upgrading the project road is attributable to reduced travel time and smooth road surface hence reduction in vehicle operating costs and more

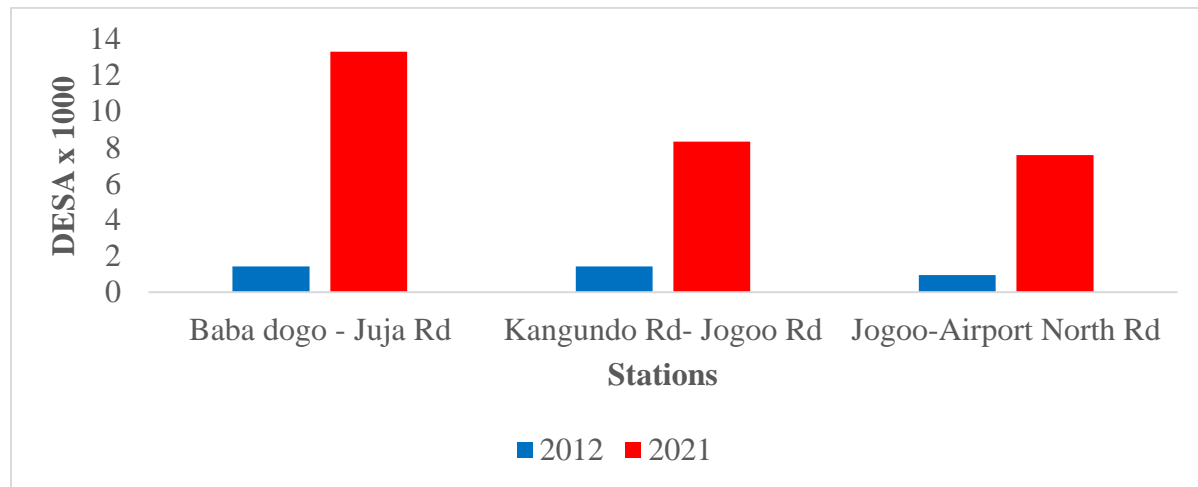
Figure 2: Comparison of 2012 and 2021 DESA

Upgrading of the road resulted in a significant increase in traffic loading, confirmed by the growth

rates, which are higher than the projected rates during the design year. The comparison of DESA between the project design year (2012) and 2021 is illustrated in *Figure 2* below.

A typical long-term growth curve is a combination of an exponential growth rate followed by a linear growth rate and, lastly, a declining growth rate. The exponential growth rate is usually 5 years after the opening of the road, while linear growth rate goes to around 10 years, and in the last 5 years, the growth rate declines (Oregon Department of Transportation, 2022). Therefore, Outer Ring Road is currently experiencing an exponential growth rate that is expected to normalise with time to achieve a linear growth rate. This calls for close monitoring of the traffic on the road to get the actual growth rates with time which may be influenced by micro or macro factors. Traffic monitoring is of paramount importance to an effective pavement maintenance strategy as it establishes the actual year the anticipated design traffic will be reached and

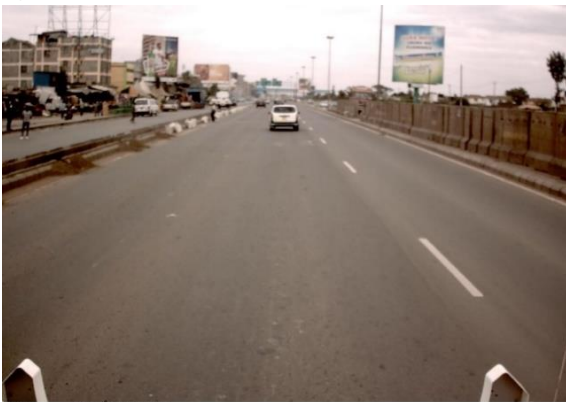
Figure 3: Pavement surface condition

The surface condition survey indicated that the pavement surface condition is generally good except at Km 5+329 and Km 7+177 which were observed to have mild rutting at LHS and RHS, respectively, as shown in *Figure 3*.

Survey: OUTER RING ROAD_LHS_LL
 Camera: 1 BASLER BIP2-1600-25C (21397646)
 Frame No: 552
 Chainage: 5.329 km
 SubChainage: 5.129 km
 Vehicle location: Lat: -1.2848662 Lon: 36.8839053 Alt: 1626.9
 Road name: OUTER RING ROAD
 From: 2 ALLSOUPS
 To: 3 DONHOLM

The distress could have resulted purely from poor construction at these specific sections and/ or in combination with high traffic. The sections call for immediate maintenance intervention measures and monitoring to prevent further deterioration of the pavement.

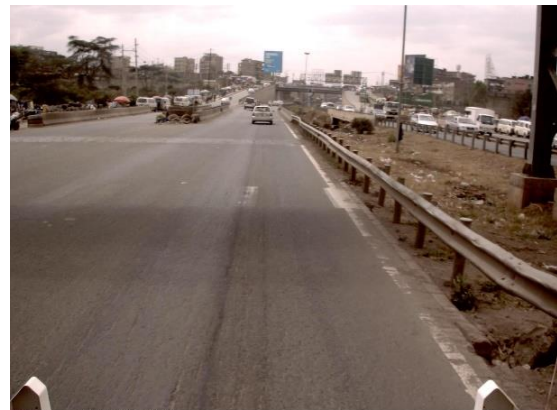
Survey: OUTER RING ROAD_RHS_OR
 Camera: 1 BASLER BIP2-1600-25C (21397646)
 Frame No: 730
 Chainage: 7.177 km
 SubChainage: 6.940 km
 Vehicle location: Lat: -1.2853481 Lon: 36.8799223 Alt: 1607.1
 Road name: ROAD NAME
 From: 2 DONHOLM CIV 1
 To: 3 NAIROBI RIVER

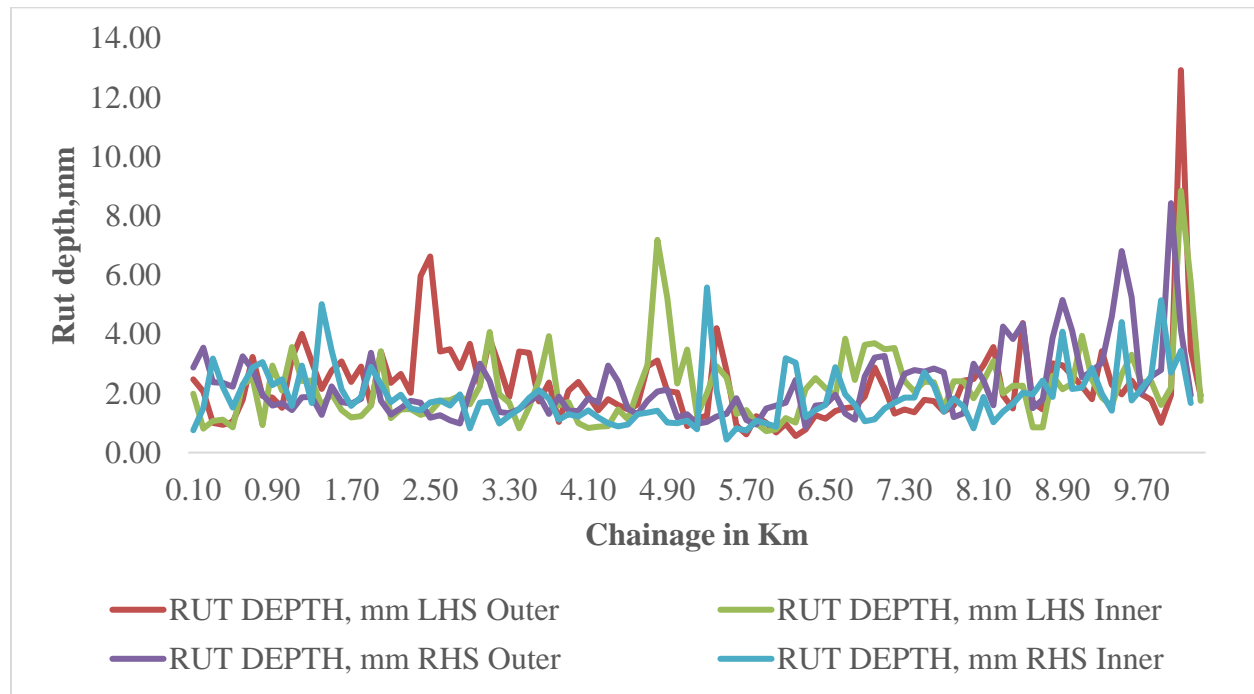
Figure 4: Rutting along the Outer Ring Road

Rut depth measurements were taken for the entire road length, and it was established that all the sections had characteristic rut depths less than 6mm, hence rated as 'No rutting'. This implies that the entire road is generally in good condition. The graphical representation of the rut depth measurements for the entire road is shown in *Figure 4* below.

It was observed that the characteristic rut depths on the reinforced earth sections were generally higher than the general lane characteristic rut depth for the

entire road. Three sections of the reinforced earth showed low severity, while the rest had no rutting.

The deterioration mechanism of rutting based on the Kenya road design manual is densification which can occur in the subgrade and or other pavement layers, particularly the subbase and base. The possible causes are insufficient stability of the base and/or subbase, insufficient base thickness or insufficient subgrade compaction (Sharad & Prof.Gupta, 2013) (Ministry of Roads and Public Works, 1988). The pavement for the entire road is uniform and constructed in the same period; it is apparent that the cause of rutting would arise from insufficient compaction of the backfill material of the embankment.

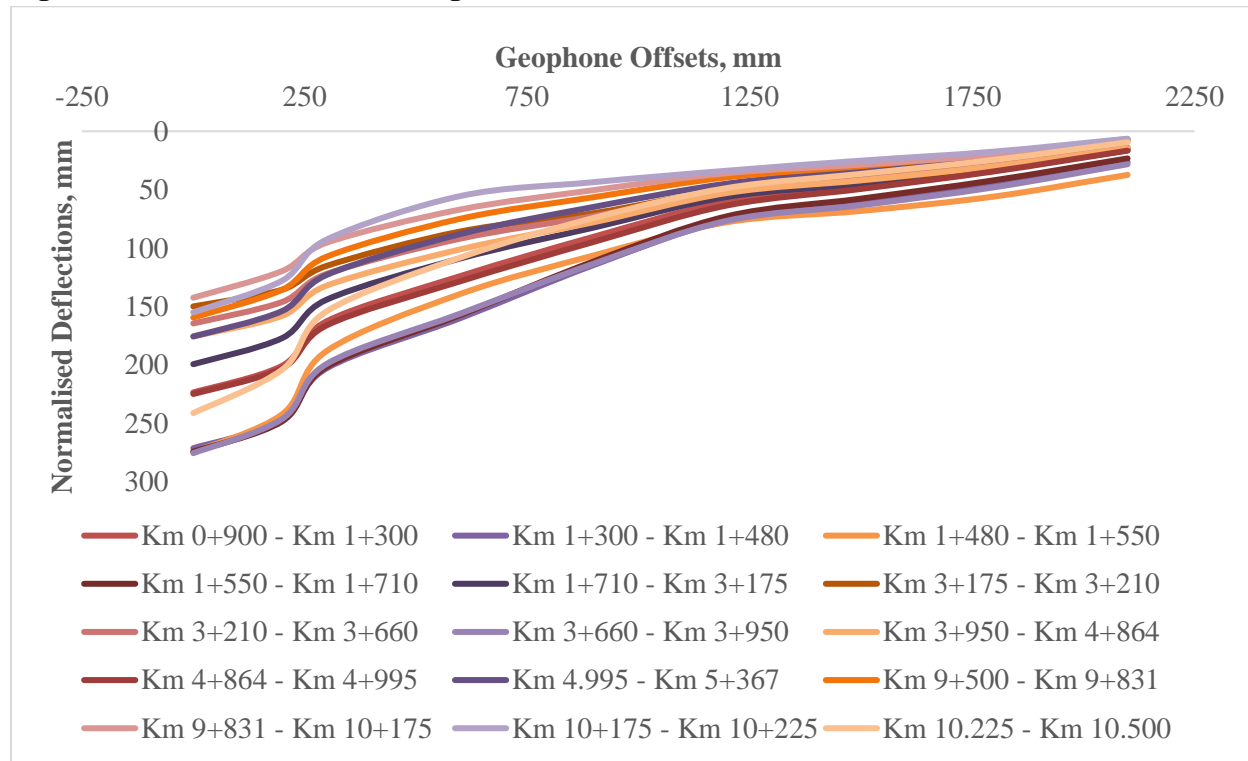
Figure 5: Deflection bowls of homogenous sections

It was observed that pavement deflections decreased with increasing geophone offsets from the centre, as graphically presented in the form of deflection bowls in *Figure 5*.

The sections with the highest deflection measurements had the maximum characteristic deflection. It was also observed that pavement on reinforced earth embankments recorded higher

deflections than the adjacent pavement on normal sections. The mean and characteristic deflections on reinforced earth embankment sections are shown in *Table 9*.

The high deflections on reinforced earth sections are a good indicator that the borrowed design manuals and construction guidelines are not addressing the local conditions for embankments materials and or construction methodologies and, therefore, not achieving the expected benefits of reinforced earth structures.
