East African Journal of Environment and Natural Resources

Volume 8, Issue 1, 2025

A Framework for Managing Water Quality from Hand-dug Well: A Case of Mutukula Town Council, Uganda

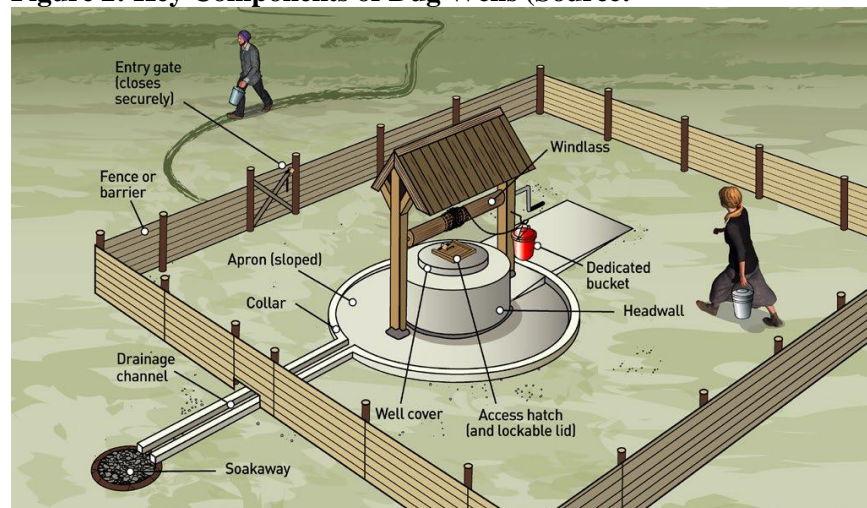
Figure 2: Key Components of Dug Wells (Source:

With reference to the sanitary inspection tool kit, all five of the hand-dug wells S1-S5 had a provision for a bucket and rope to draw water but did not have in place other components such as a collar, apron, drainage channel, soak away, fence or barrier. Refer to Figure 2 to appreciate the key components expected within such wells;

All 5 wells had in place inner walls built from the ground as lining and well support structures. It was also identified that for all the wells considered, the depth ranged between 9-12m while the well age ranged between 4 to 8 years. Only one of the wells coded S4 had a properly constructed headwall and metallic well cover while all the other 4 wells

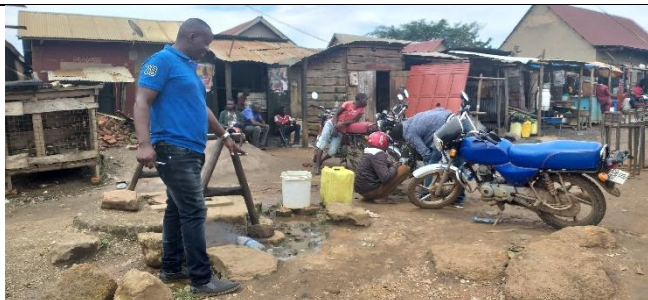
<ul style="list-style-type: none"> -Inside well diameter-1.2m - Built with a masonry wall from the ground -Surrounded by commercial activity, shops and makeshift motorbike repair - Well considered functional since water was collected for use. -Well had bucket and rope installed by the owner
S2	-1.0001238, 31.4156919

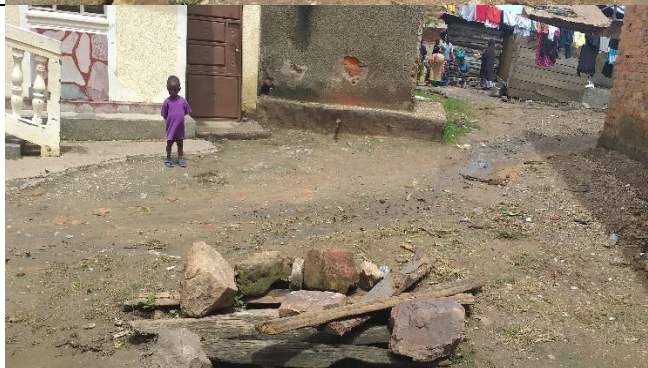
<ul style="list-style-type: none"> -Inside well diameter 1.1m - Built with a masonry wall from the bottom -Makeshift cover -Surrounded by residential establishments, including pit latrines located less than 15m away - Well considered functional since water was collected for use

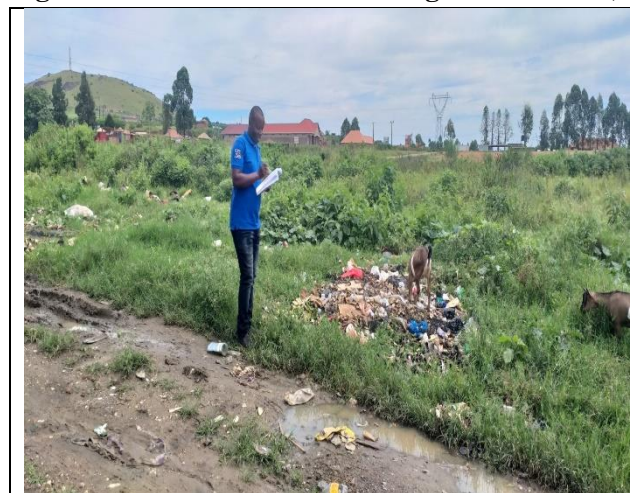
Figure 3: Pictorial of Surroundings Near Wells (author shown in images for scale)

Some of the open waste dumpsites near residential establishments where faecal matter was also disposed of in polyethene bags.

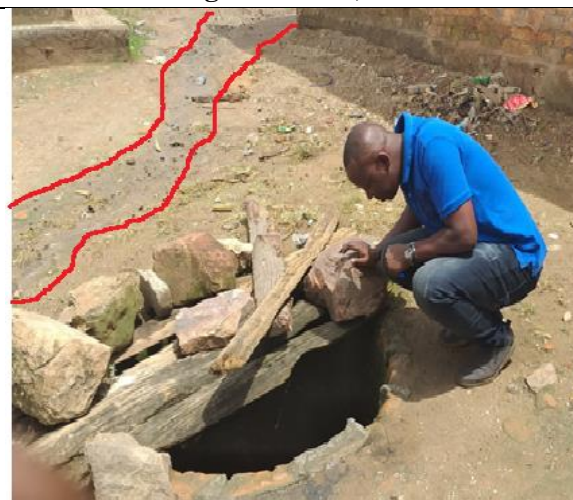
Rainwater run-off path, disposal of waste close to hand-dug well S 3 with poor cover

central collection point while others also had waste collected within residential compounds near the wells, posing a risk in case of stormwater run-off carrying the waste to poorly covered wells.

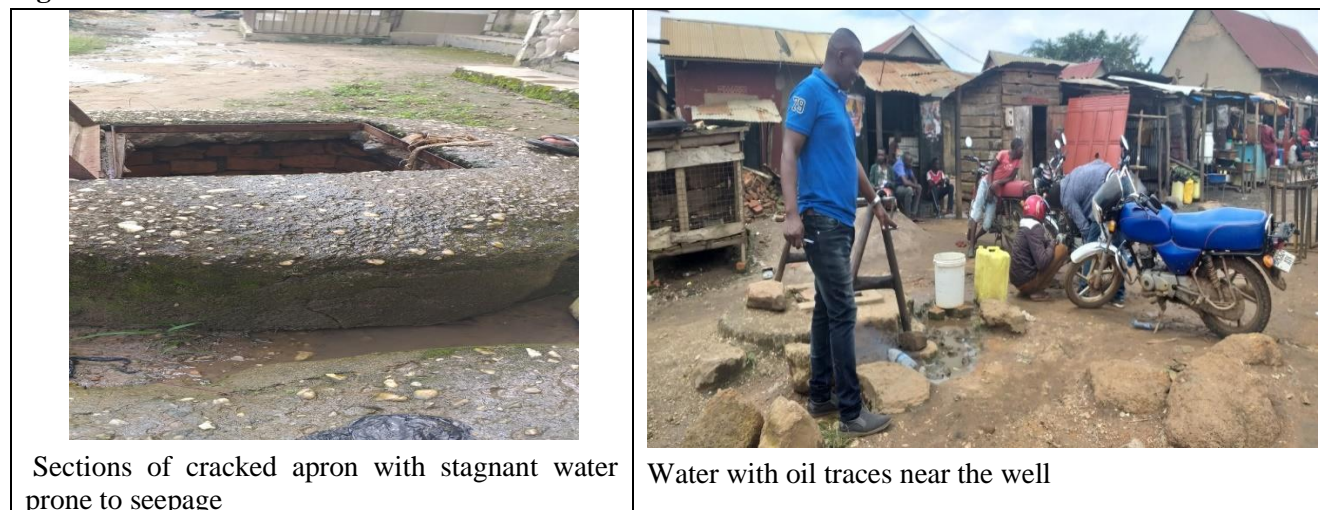
Figure 3: Other Activities Carried Out Around Wells

some of the activities taking place near well S4 that could lead to contamination of the wells.

Sections of cracked apron with stagnant water prone to seepage

Water with oil traces near the well

It was also identified that other activities were carried out in the surroundings of the wells for instance repairs and or engineering works for motorcycles were carried out next to well S4. The makeshift mechanic/garage establishments where repairs on motorcycles were carried out were seen as potential sources of pollutants such as oil spills and suspended material from packaging for various components. A risk of these waste streams ending up in the well was identified and this was in line with other studies carried out by authors like Dietler et al. (2019) and

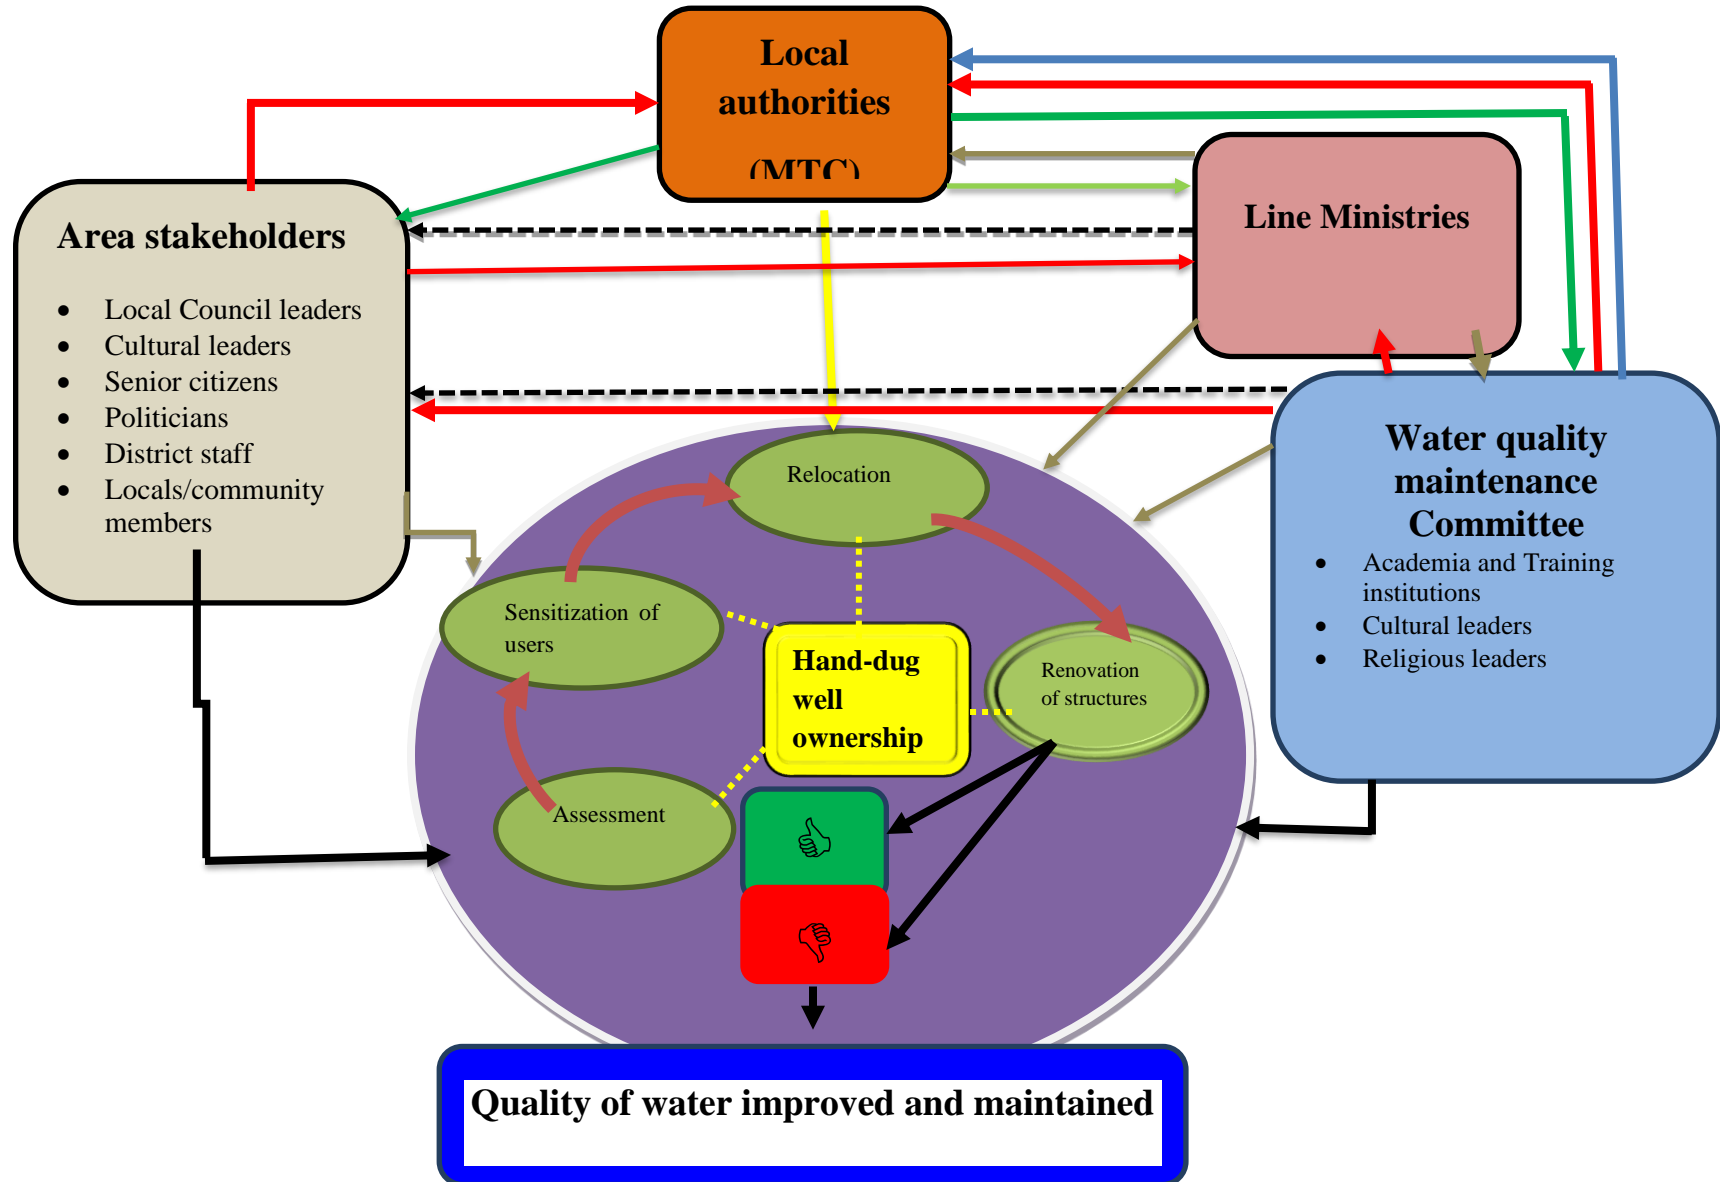
Figure 9: Framework for Maintenance of the Quality of Water in Hand-dug Wells

As highlighted in Table 5, the key components of the framework were informed by the design requirements and design decisions that were proposed after careful consideration of the findings from quality assessment of water samples, engagement of various stakeholders and reference to best practices in water resources management to mention but a few. Although reference was made to Mutukula Town Council, the authors propose that adjustments be considered to cater for the uniqueness of other urban entities with similar contexts i.e. depending on the nature of the water supply systems and varying monitoring requirements stipulated by mandated authorities. For instance, not all ecological environments have cultural leaders while also, while the localities have different layers of leadership implying the composition of the implementation team may vary. Thus, the authors proposed the framework shown in Figure 9.

A brief description of the roles of the various stakeholders deemed crucial to the framework follows;
