East African Journal of Environment and Natural Resources

Gully Erosion associated with Peri-Urbanization: Focus on the Catchments around Kimwenza in the South of Kinshasa (DR. Congo)

Prof. Fils Makanzu Imwangana, PhD^{1*}, Blaise Kamosi Zola¹, Joyce Mbiya Kangudia² & Prof. Serge Pangu Sanghy, PhD¹

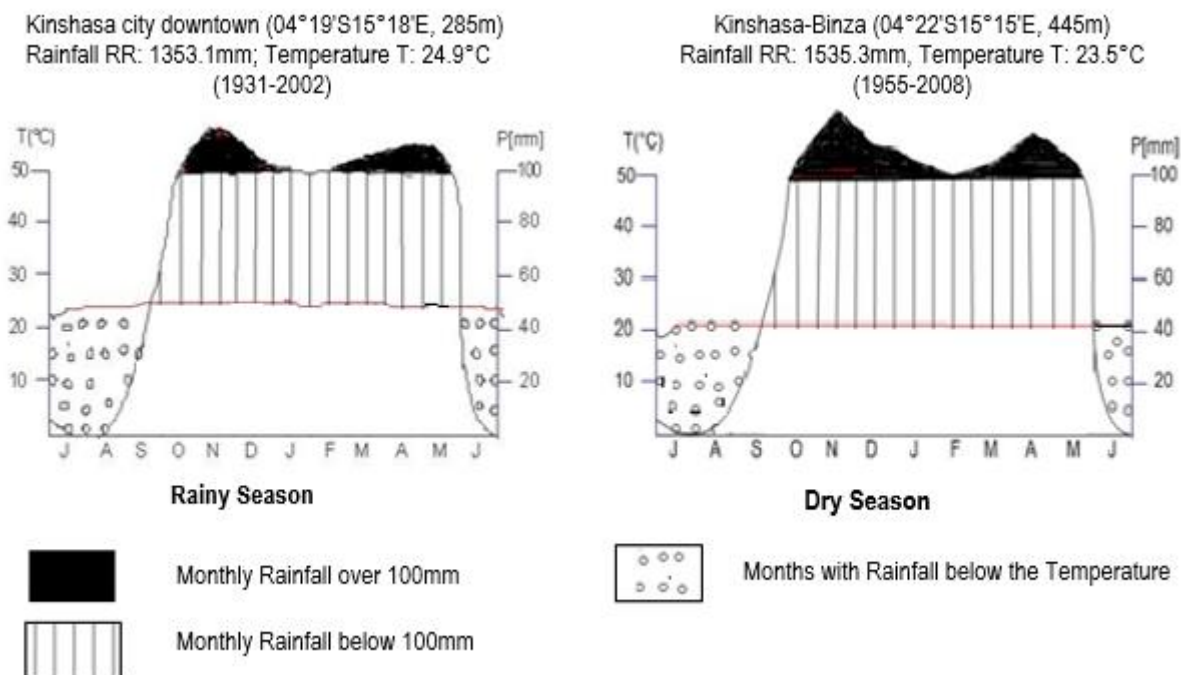
Figure 3: Umbrothermal Diagram of Kinshasa (1932-2008) from Pangu Sanghy (2011)

in general, and the study area, in particular, experience an Aw₄-type climate, with an average annual rainfall of 1,400 mm and an average daytime temperature exceeding 18°C (Figure 3).

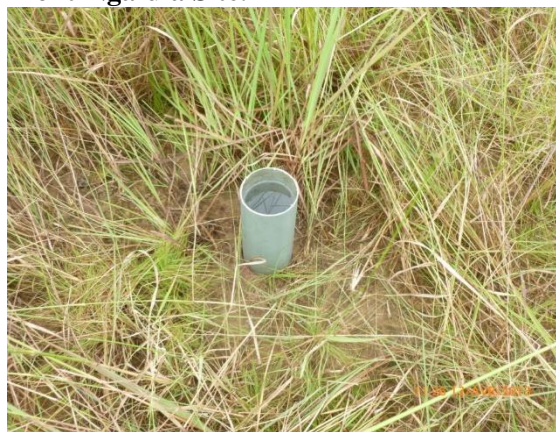
Figure 5: *In situ* Soil Permeability Test at the Mont-Ngafula Site.

- The technique involves measuring in situ the dynamics of water infiltration into the soil by determining the permeability of each horizon in several pedological profiles along the slopes of gullies that cut through the Mont-Amba and Mont-Ngafula to deduce their behaviours. For this purpose, the walls of the gullies were cleared using a spade from top to bottom of the profile to refresh and visualize the horizons, which differ by their colouration. This choice was arbitrary for all observation points. Five field trips were made to collect soil samples and conduct in situ permeability and laboratory tests. The choice, although arbitrary, is based on the number of sub-catchments, five in total, due to a single transect per sub-catchment. A total of 15 samples were selected for granulometric analyses and infiltration tests in the laboratory, with three samples from each of the five chosen transects. At each of these sampling points, we performed in situ soil permeability tests using a simple ring, 20 cm in length, with 5 cm of the ring embedded in the soil (Figures 4 and 5).

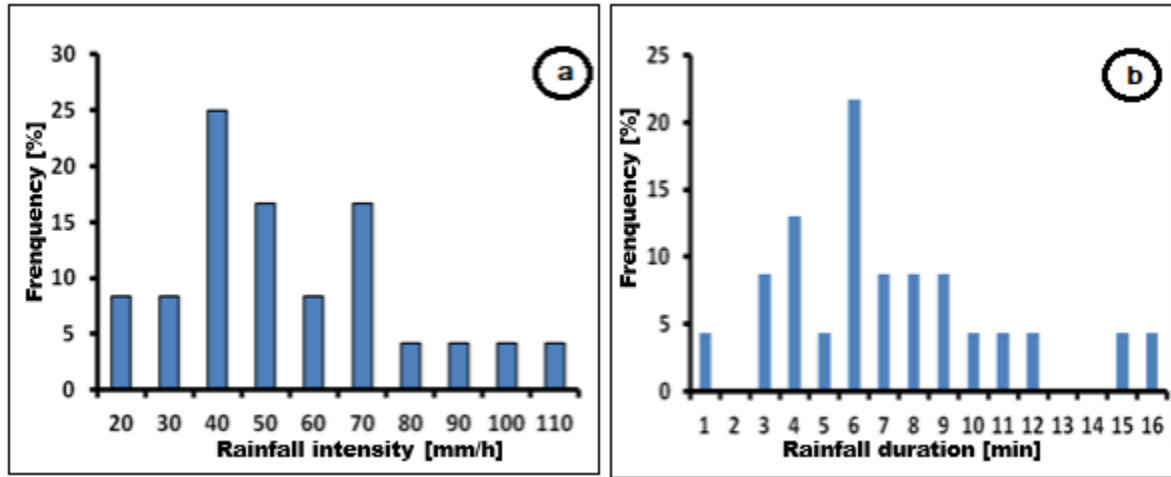
Figure 11: (a) Frequency of Erosive Rainfall Intensities (b) Frequency of Their Observed Duration in Kinshasa-Binza During the Period 1975-2005 (Source: Makanzu Imwangana, 2014).

from those with an intensity between 51 and 70 mm/h. The duration of these rains varies from 45 minutes to 15 hours and 18 minutes, with an average of 6 hours and 47 minutes (Figure 11).

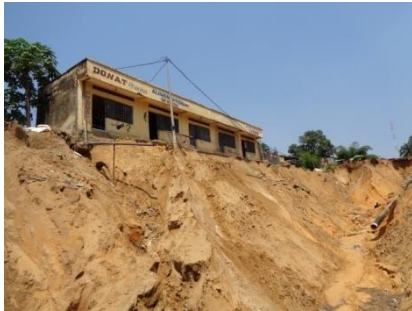
Figure 17: Head of the Main Gully on the Kimwenza Road at Km 7, Dated May 12, 2021.

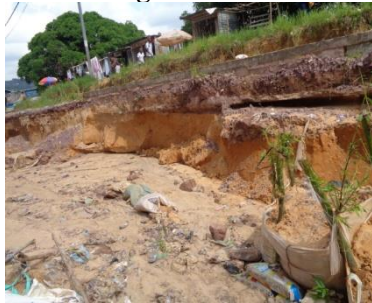
Figure 18: Km5: Failure of the Work Initiated by a Chinese Company Responsible for Resurfacing the Road.

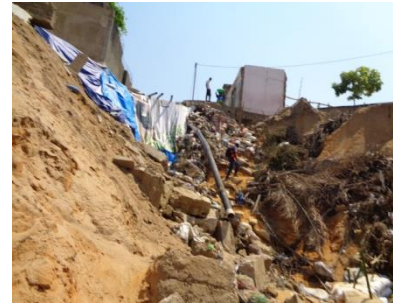
Figure 19: Poor Drainage of Rainwater Causing Streets Erosion.

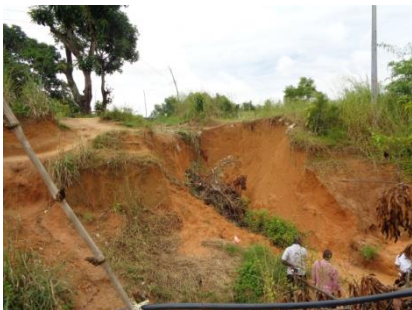
Figure 20: A Typical Case of Erosion Starting at the Intersection of a Street and the Main Road.

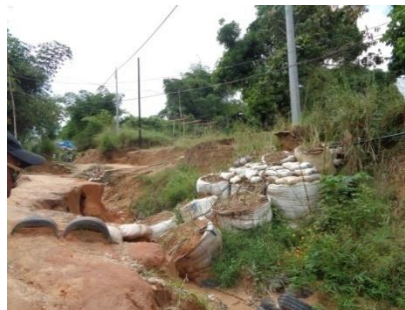
Figure 21: A Typical Case of the Threat of a Power Pole Falling by SNEL Along the Eroded Road.

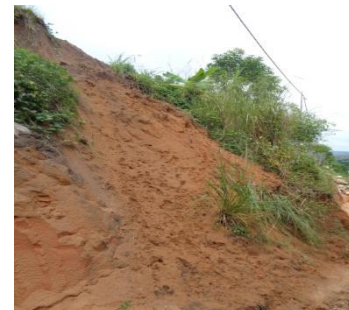
Figure 22: Landslide of Gully Walls Along the Road Shows Evidence of Undermining at the Base and/or the Presence of Clay.
